# PRESTON AIRPORT

Using the branch, section and sample unit divisions established, a visual condition survey was conducted at Preston Airport on November 04, 2006. During the inspection pavement defects were identified and measured in accordance with the methodology outlined in FAA AC:150/5380-6 and ASTM D5430. Our inspection ensures your airport complies with the “detailed inspection” requirement of FAA’s PMMP guidelines. After collection, the data were entered into the Micro PAVER software for analysis. These data are reproduced in the Re-Inspection Report attached in Appendix 2. Photographs of typical distresses observed during the inspections are provided in Appendix 3.

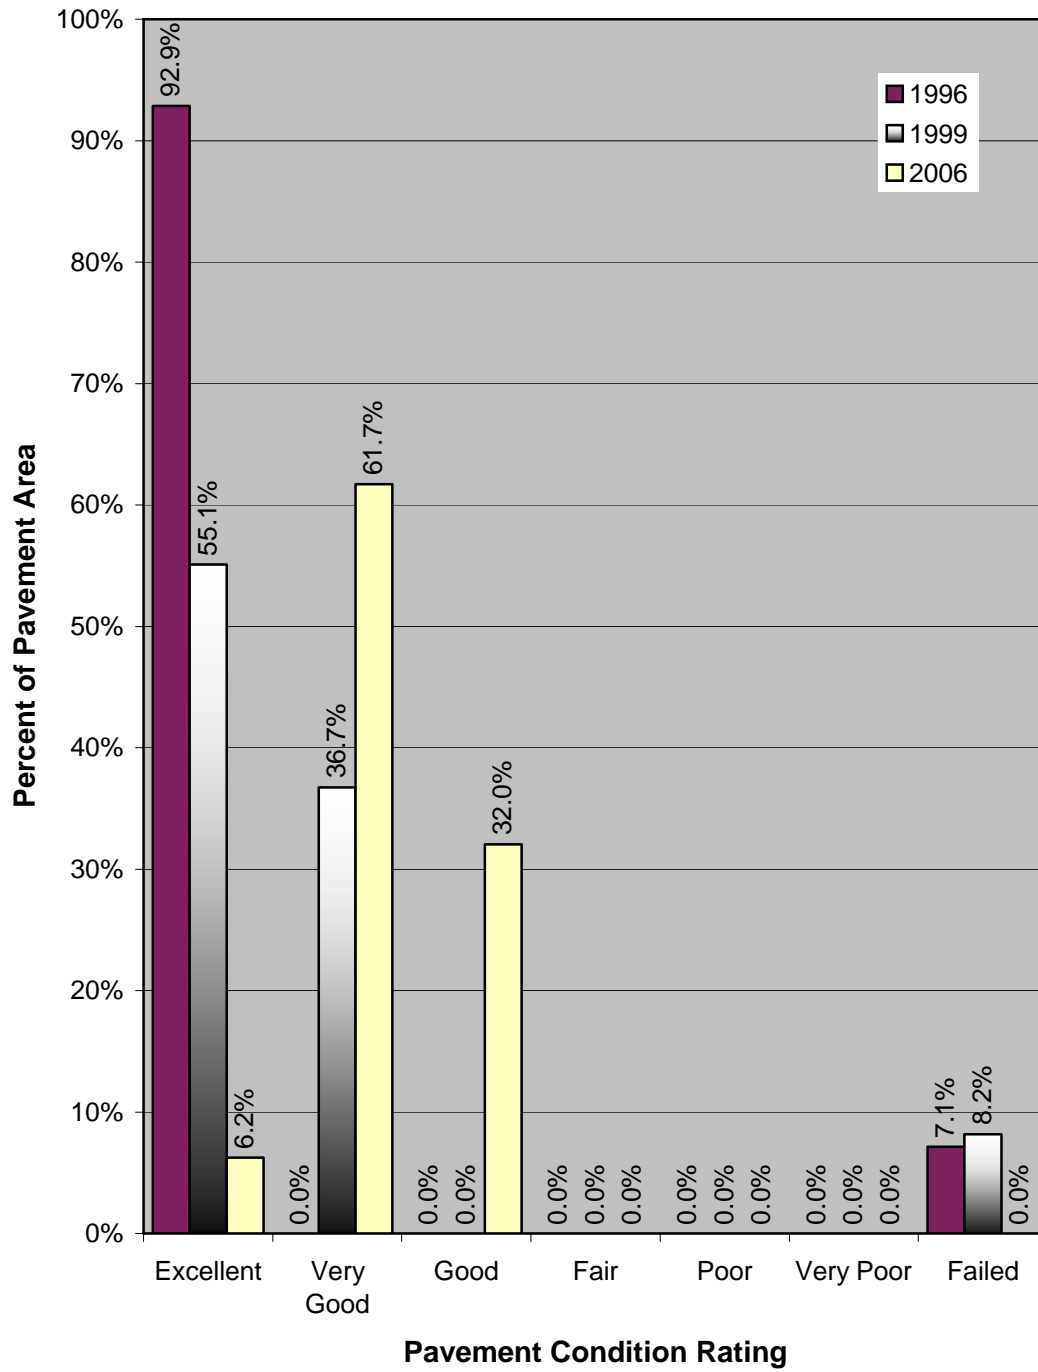
**Figure PS-4. Distribution of Pavement Condition  
Preston Airport**

Section PCIs at the airport range from a low of 67 (a PCR of “Good”) to a high of 96 (a PCR of “Excellent”). The area-weighted average PCI for all airport pavements is 76, corresponding to an overall PCR of “Very Good”. Figure PS-4 shows how much pavement area is associated with each Pavement Condition Rating category and also shows pavement condition distribution from the inspections conducted in 1996 and 1999. A graphical representation of the projected PCRs presented in Table PS-2 is shown in Figure PS-5.
